## **ANNUAL REPORT FOR 2004**

# **Hatteras Island Inlet Site Dare County**

Prepared By:
Office of Natural Environment & Roadside Environmental Unit
North Carolina Department of Transportation
December 2004

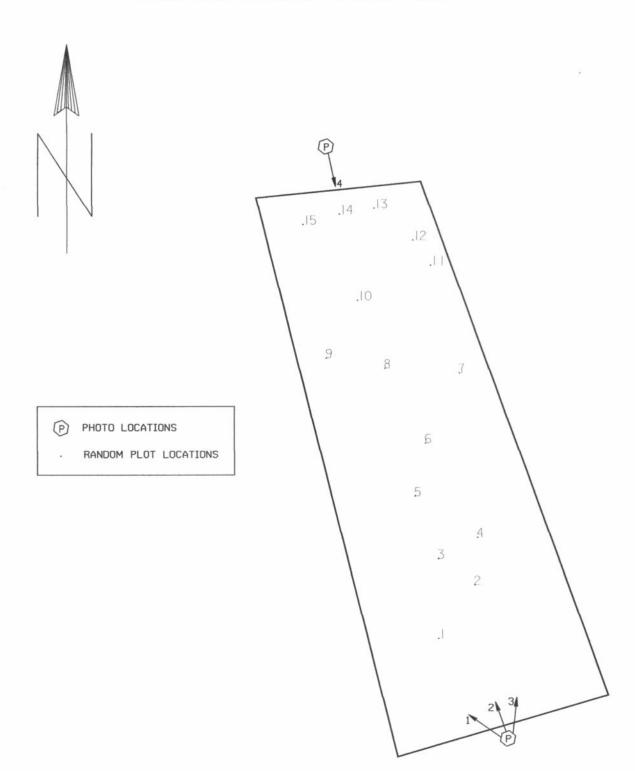
### Hatteras Island - Inlet Site

SITE PHOTOS/PHOTO AND VEGETATION PLOT LOCATIONS
